Manhole Inspection Summary

Manhole # S35MM_037MH

Insp Date: **3/5/07 1:58 PM**

Location Address: **2109 GUILDFORD AVE**

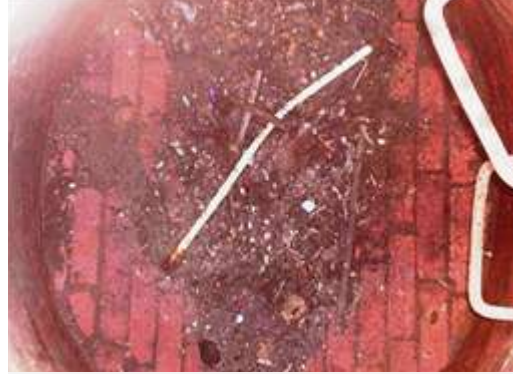
Top View

Channel debris.

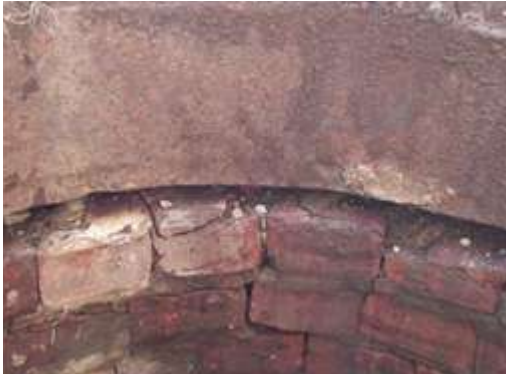
Defect

Condition: ☐ Sound ☐ Cracked ☐ Root Intrusion ☒ **Loose Brick** ☒ **Deteriorated**

Infiltration: ☐ None ☒ **Joint** ☐ Cracks ☒ **Mortar** ☐ Roots ☐ Wall

Frame leaks. Adjustment deterioration, loose brick and infiltration.

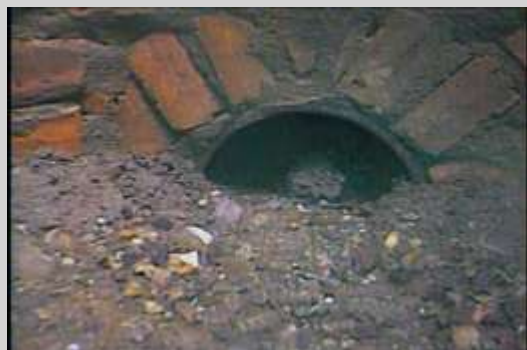
Pipe Out @ 12 O'Clock

Deposits: ☐ None ☒ **Mud** ☐ Sludge ☐ Debris ☐ Grease

Silt Depth: **4** (in.)

Deposits Extent: **Heavy**
